January 21, 2020  
**Notice of Inspection**  
DAM #D183010

RE: Harvey Lake Dam #D183010, Northwood  
Hazard Classification: Non-menace

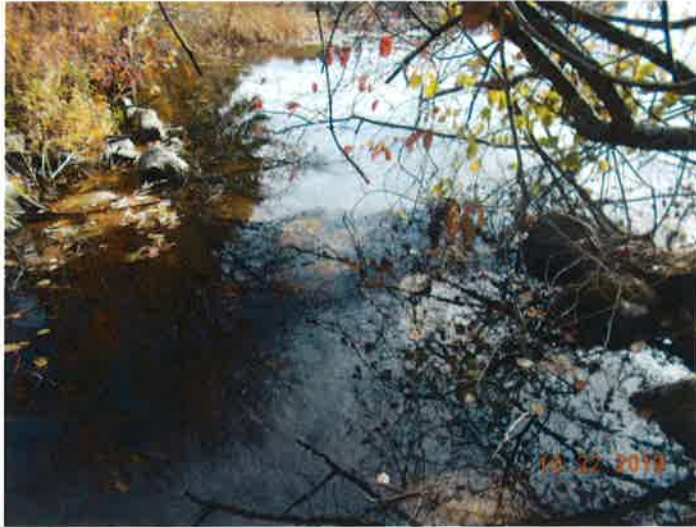
DSCN2390

4. Some submerged sandbags were observed approximately 15' upstream of the concrete portion of the dam when it appears that someone has attempted to construct a sandbag dam (Photo 2390) – See sketch attached. Similar to the comment above, given that the sandbags appear to have been in-place for considerable time, NHDES will not require them to be removed; however, placement of further sandbags will constitute a wetlands violation; and

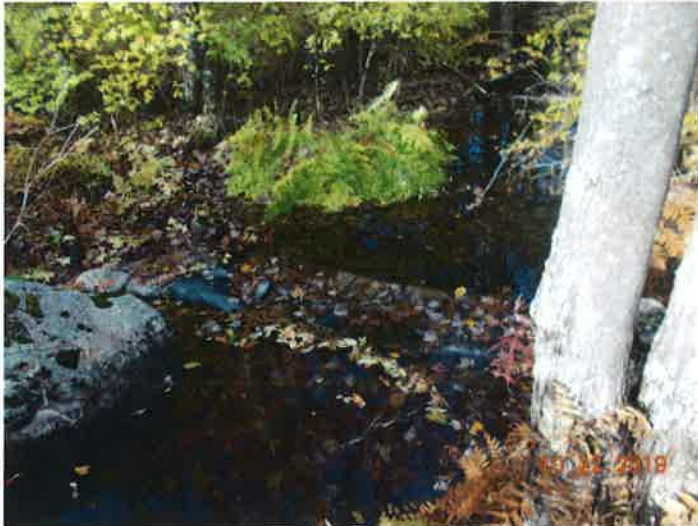
D183010 Harvey Lake Dam, Northwood, NH - Inspected October 22, 2019  
DSCN2392

3. NHDES observed an approximately 6' wide breach that had been plugged up with sandbags on the left side of the dam located approximately 10' left of the concrete spillway (Photo 2392) – See sketch attached. Given that the sandbags appear to have been in-place for considerable time, NHDES will not require them to be removed; however, placement of further sandbags will constitute a wetlands violation and any further attempts to repair/reconstruct the breached area will require permits from both NHDES's Dam Safety and Wetlands programs. Dam reconstruction is defined in RSA 482:2X which has been reproduced below. Please note, that per the RSA definition, other modifications to the dam could also require a Reconstruction permit.
